Debris/Ice/TPS Assessment And Integrated Photographic Analysis For Shuttle Mission STS-46

September 1992

Gregory N. Katnik
NASA/Kennedy Space Center

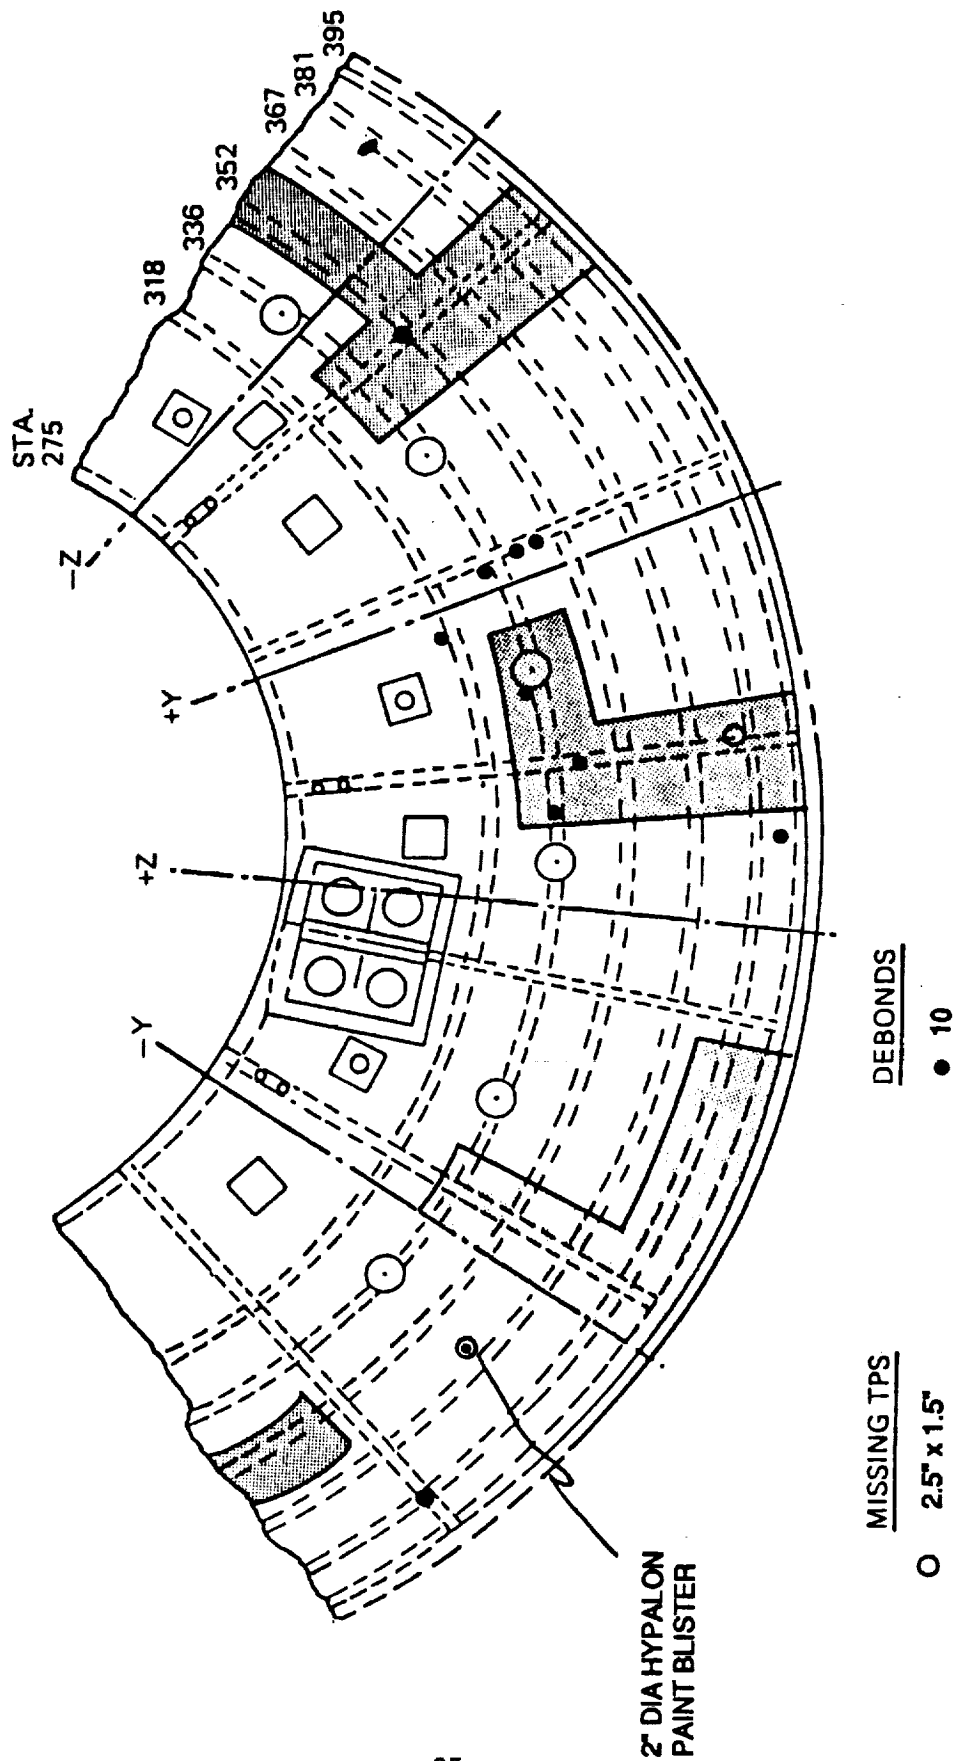
Figure 4. RIGHT SRB FRUSTUM

The RH frustum had 10 MSA-2 debonds over fasteners and one area of missing TPS, which measured 2.5"x1.5", near the 381 ring frame between the +Y and +Z axes (Figure 4). Minor localized blistering of the Hypalon paint had occurred in isolated areas. All BSM aero heatshield covers were locked in the fully opened position.

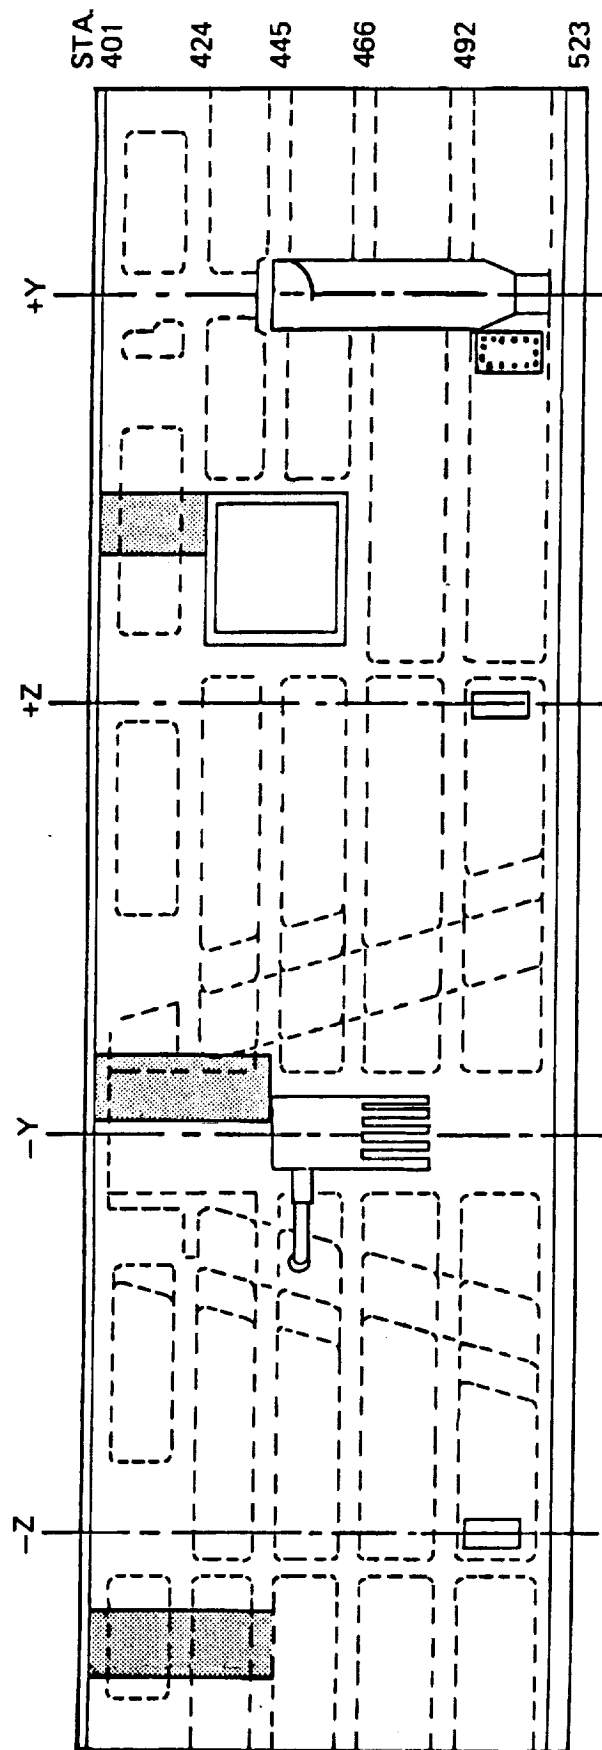
Figure 5. **RIGHT SRB FWD SKIRT**

The RH forward skirt exhibited no debonds or missing TPS. Both RSS antennae were intact and undamaged. Minor blistering of the Hypalon paint occurred on the systems tunnel cover and forward ET/SRB attach point (Figure 5). No pins were missing from the frustum severance ring. The forward separation bolt and electrical cables appeared to have separated cleanly.

TPS MISSING
NONE

DEBONDS
NONE

MINOR BLISTERING OF
HYPALON PAINT ON
SYSTEMS TUNNEL COVER
AND ET/SRB ATTACH POINT

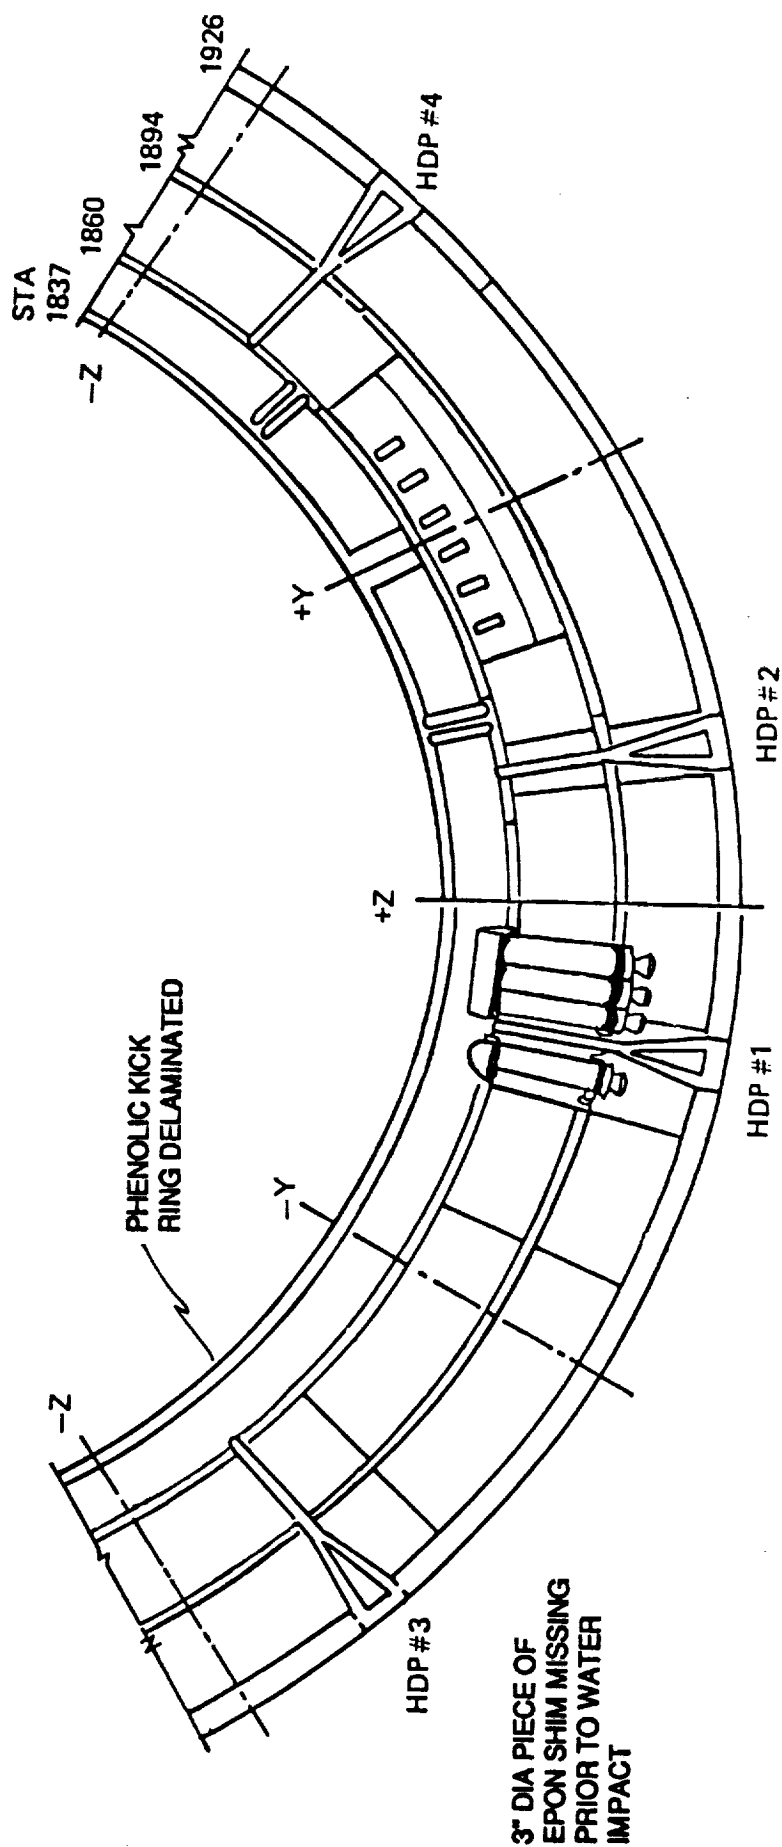
Figure 6. RIGHT SRB AFT SKIRT EXTERIOR TPS

The phenolic material on the kick ring had delaminated. The K5NA closeouts (protective domes) on the kick ring forward and aft fasteners had been eliminated. RTV-133 replaced the K5NA over the forward fasteners. The aft fasteners were uncovered. The aft skirt acreage TPS was in good condition (Figure 6).

All four Debris Containment System (DCS) plungers were properly seated. This was the ninth flight utilizing the optimized link. A 3-inch diameter piece of the HDP #3 EPON shim was missing prior to water impact (sooted/charred substrate).

ALL DCS PLUNGERS
SEATED PROPERLY

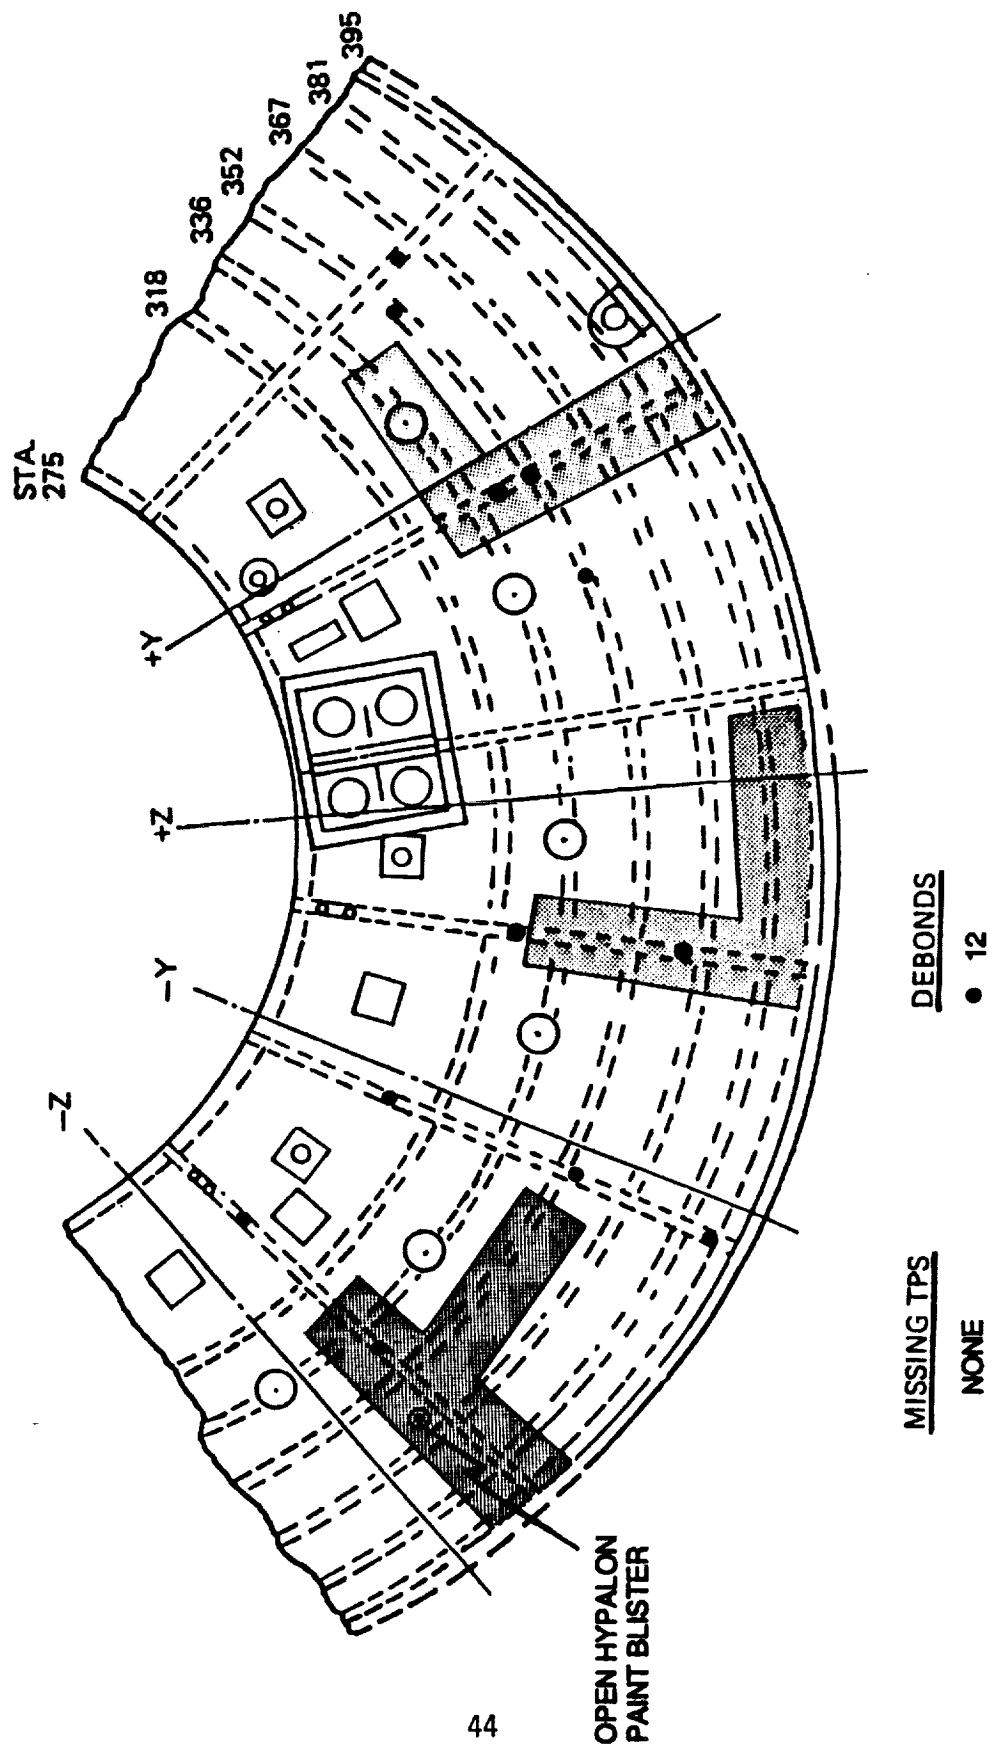
Figure 7. LEFT SRB FRUSTUM

The LH frustum was missing no TPS but had 12 MSA-2 debonds over fasteners. There was very minor localized blistering of the Hypalon paint in isolated areas. The BSM aero heatshield covers were locked in the fully opened position (Figure 7).

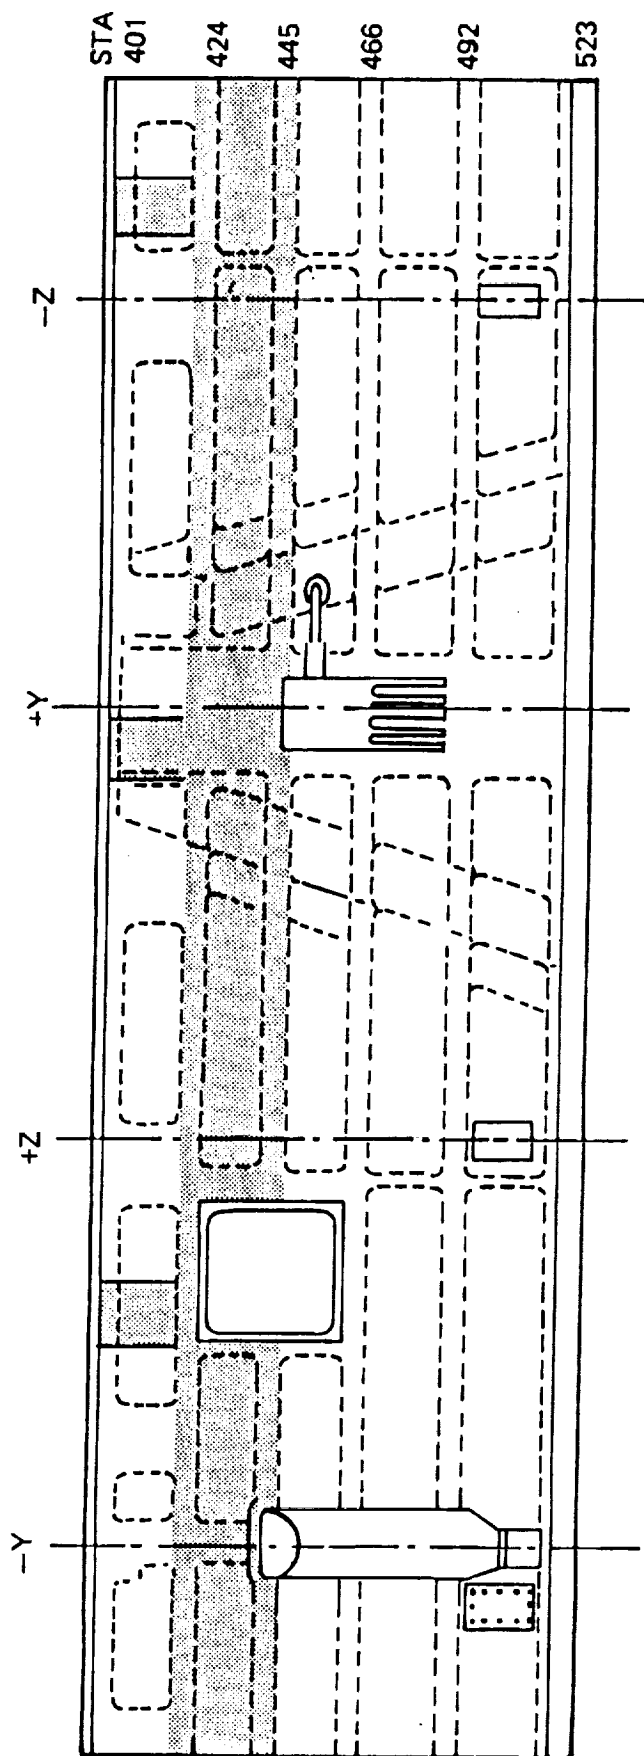
Figure 8. LEFT SRB FWD SKIRT

The LH forward skirt exhibited no debonds or missing TPS. The phenolic plates on both RSS antennae were intact. The forward separation bolt and electrical cables appeared to have separated cleanly. No pins were missing from the frustum severance ring. Minor blistering of the Hypalon paint occurred around the ET/SRB attach point (Figure 8).

TPS MISSING
NONE

DEBONDS
NONE

MINOR BLISTERING OF
HYPALON PAINT ON
ET/SRB ATTACH FITTING

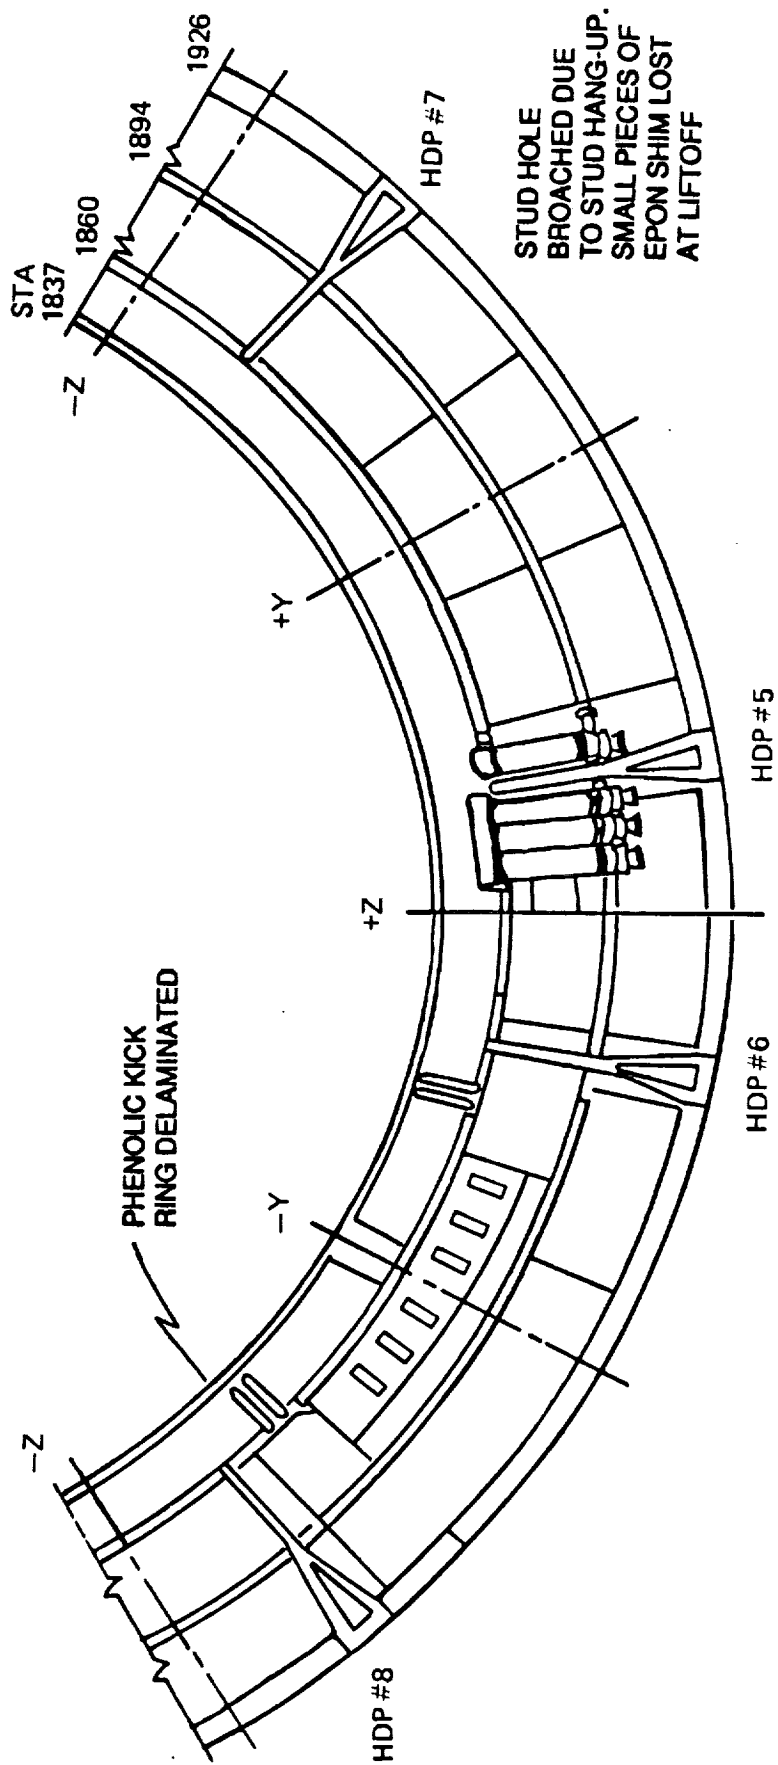
Figure 9. LEFT SRB AFT SKIRT EXTERIOR TPS

The phenolic material on the kick ring had delaminated. The K5NA closeouts (protective domes) on the forward and aft fasteners on the kick ring had been eliminated (Figure 9). RTV-133 replaced the K5NA over the forward fasteners. The aft fasteners were uncovered. The aft skirt acreage TPS was in good condition.

The HDP #7 stud hole was broached due to a stud hang-up at lift off as observed in the launch films. Small pieces of the EPON shim material adjacent to the stud hole had been pulled off by the stud. All four Debris Containment System (DCS) plungers were properly seated. This was the ninth flight utilizing the optimized link. None of the remaining EPON shim material was lost prior to water impact.

ALL DCS PLUNGERS
SEATED PROPERLY

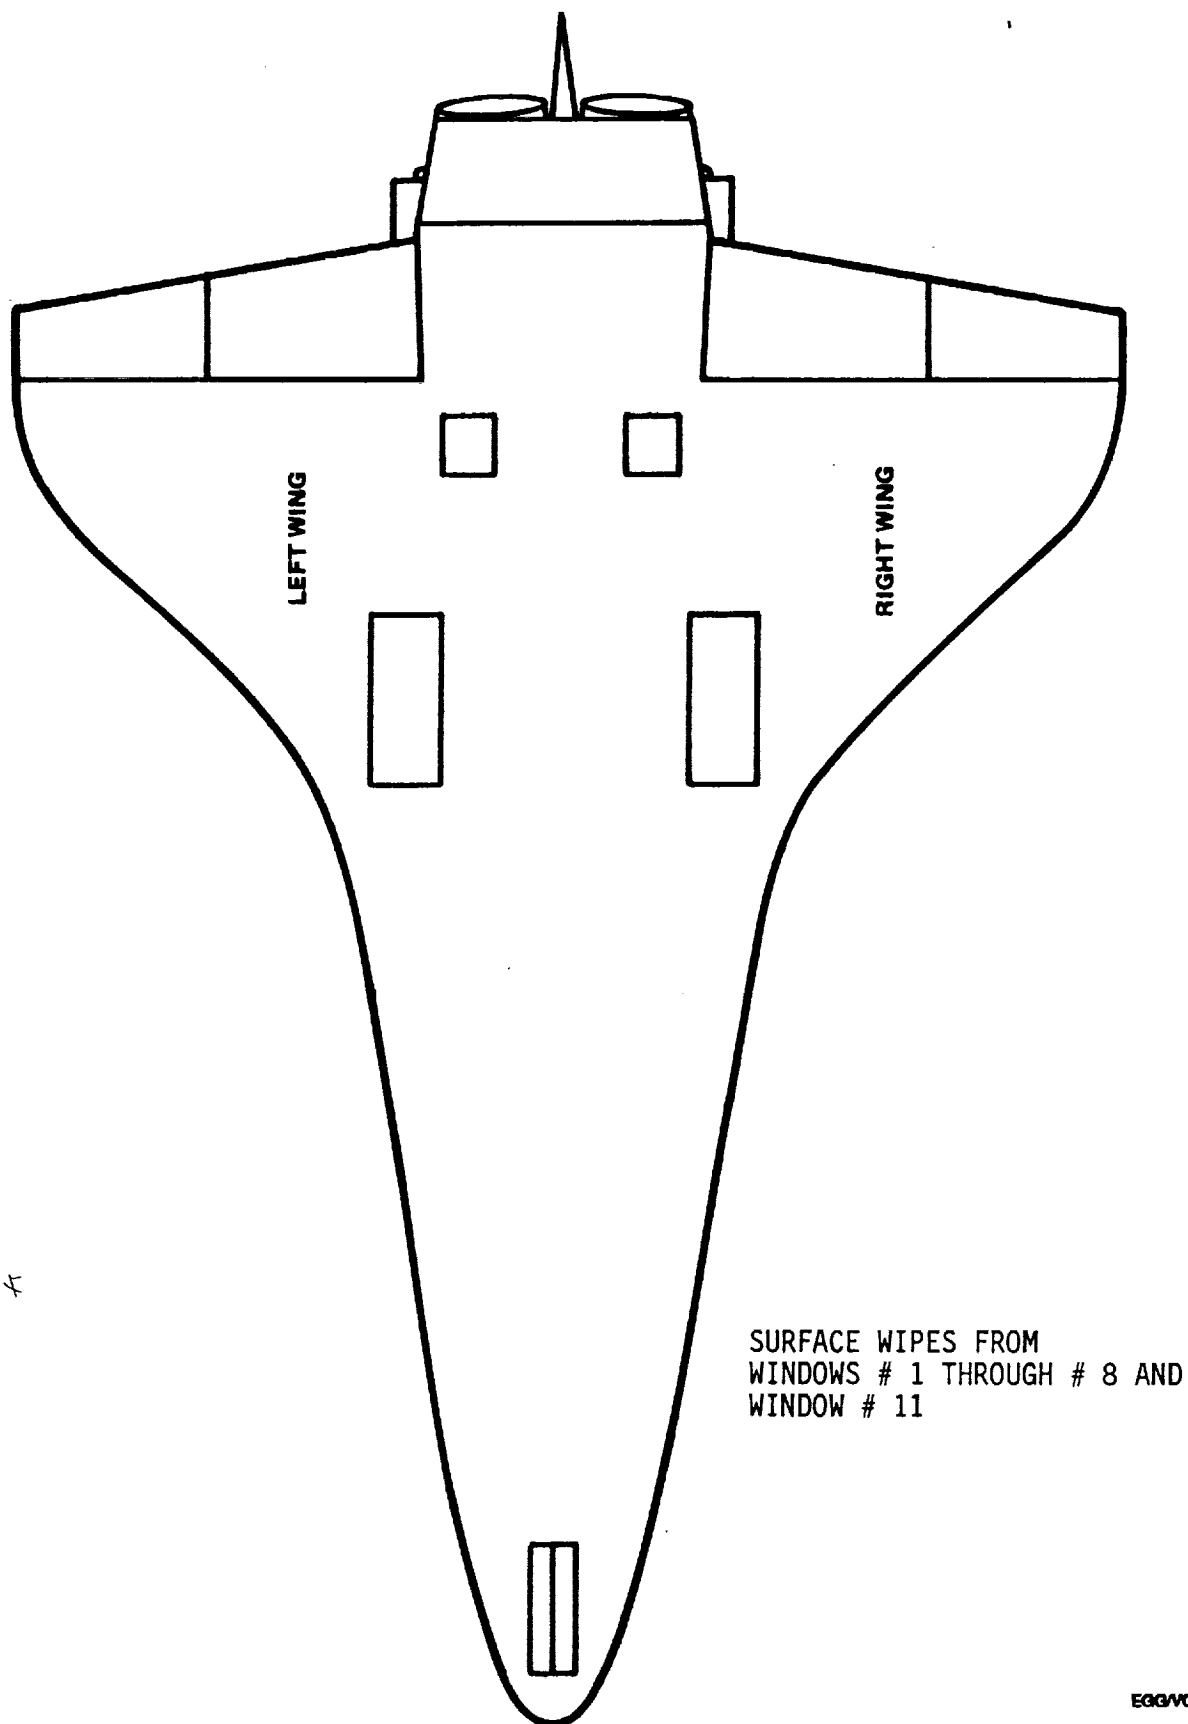
Figure 14. **CHEMICAL SAMPLE LOCATIONS**

Orbiter windows #3 and #4 exhibited moderate hazing with a few streaks. Hazing on the other windows was less than usual. Laboratory analysis will be performed on samples taken from the windows (reference Figure 14). Six damage sites were noted on the perimeter tiles around window #3. The impact sites were only surface coating losses or were no more than 1/4 inch deep. This damage may have been caused by the RTV used to bond paper covers to the FRCS nozzles or by exhaust products from the SRB booster separation motors.

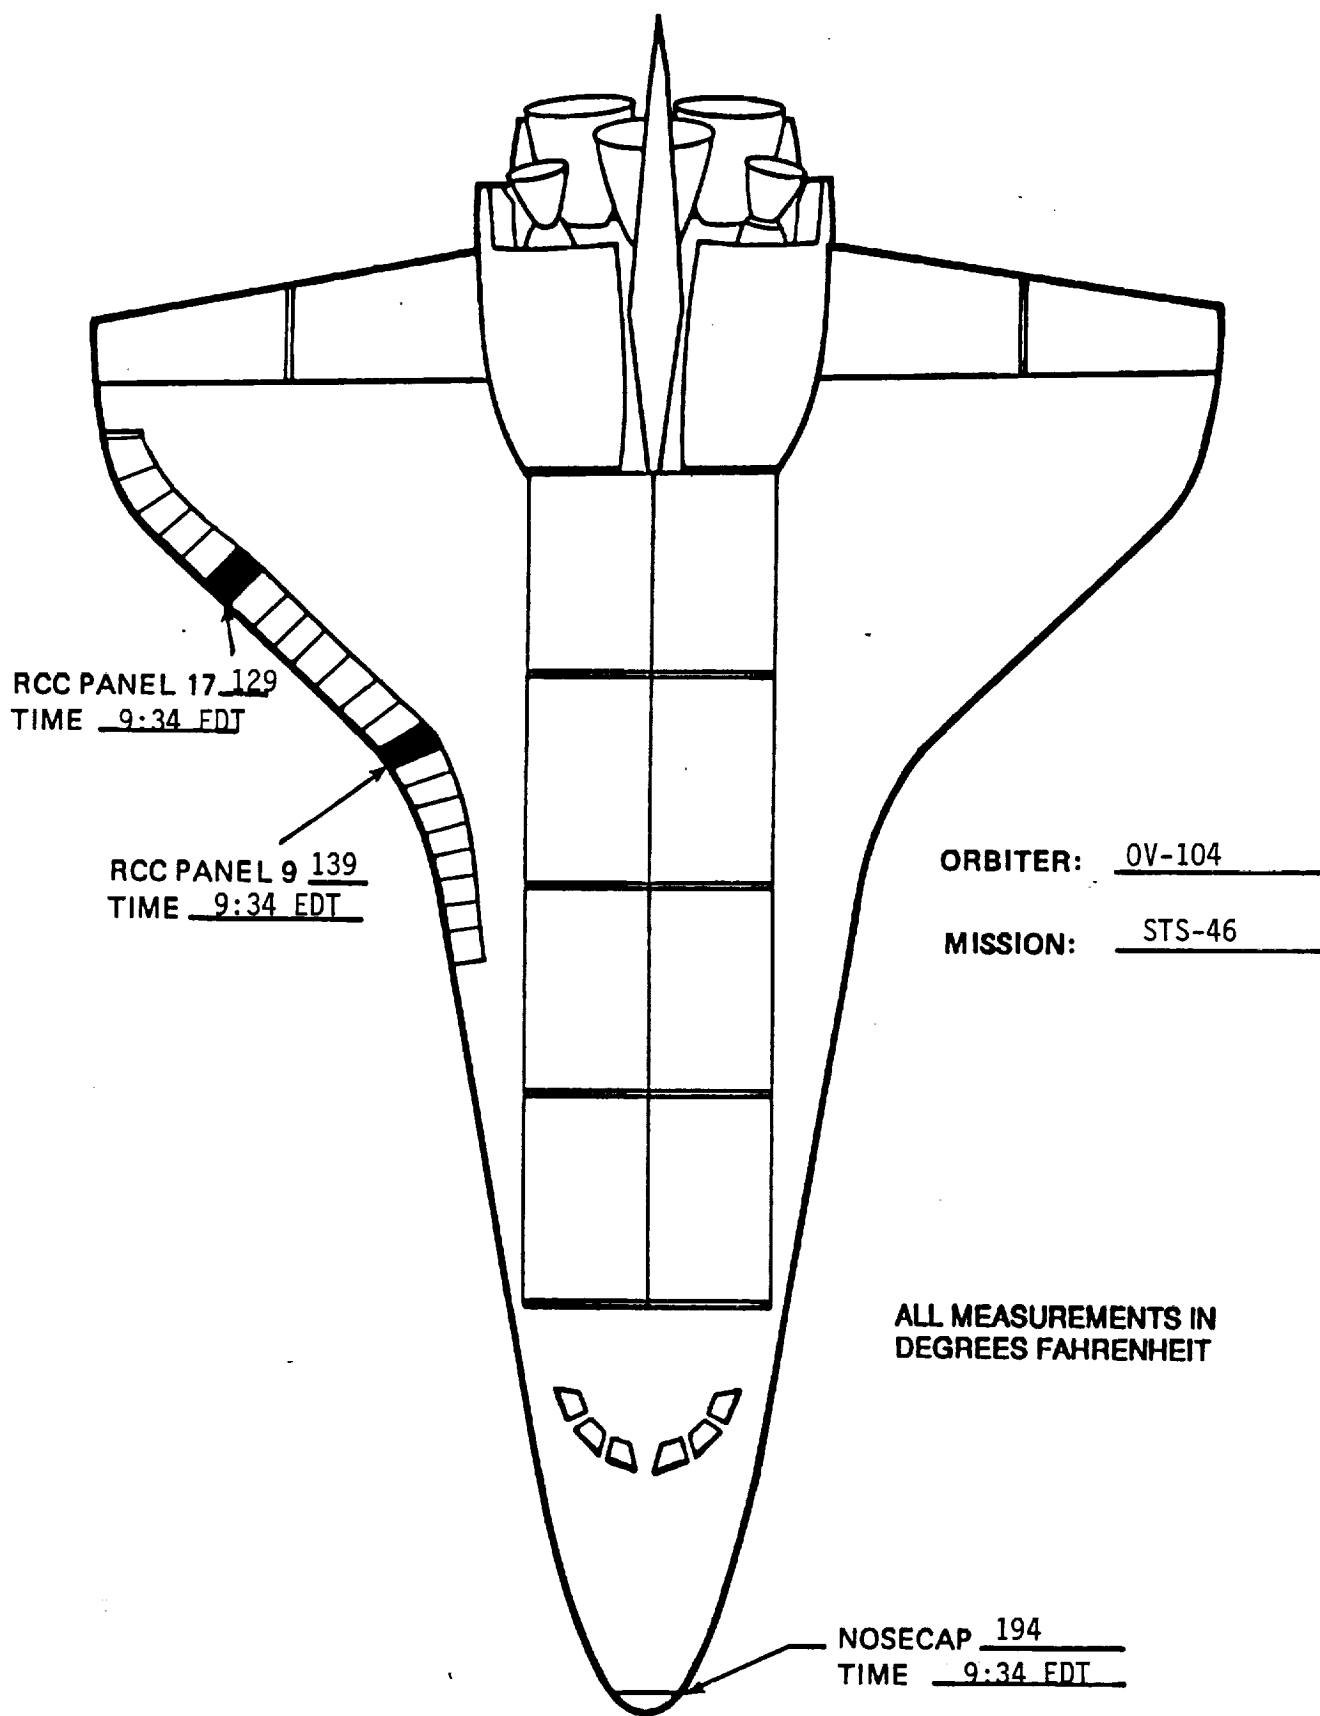
Figure 15. **STS-46 RCC TEMPERATURE MEASUREMENTS AS
RECORDED BY THE SHUTTLE THERMAL IMAGER**

A portable Shuttle Thermal Imager (STI) was used to measure the surface temperatures of three areas on the Orbiter TPS after landing (per OMRSD V09AJ0.095). Twenty-two minutes after landing the Orbiter nose cap RCC was 194 degrees F, the RH wing leading edge RCC panel #9 was 139 degrees F, and panel #17 was 129 degrees F (reference Figure 15).

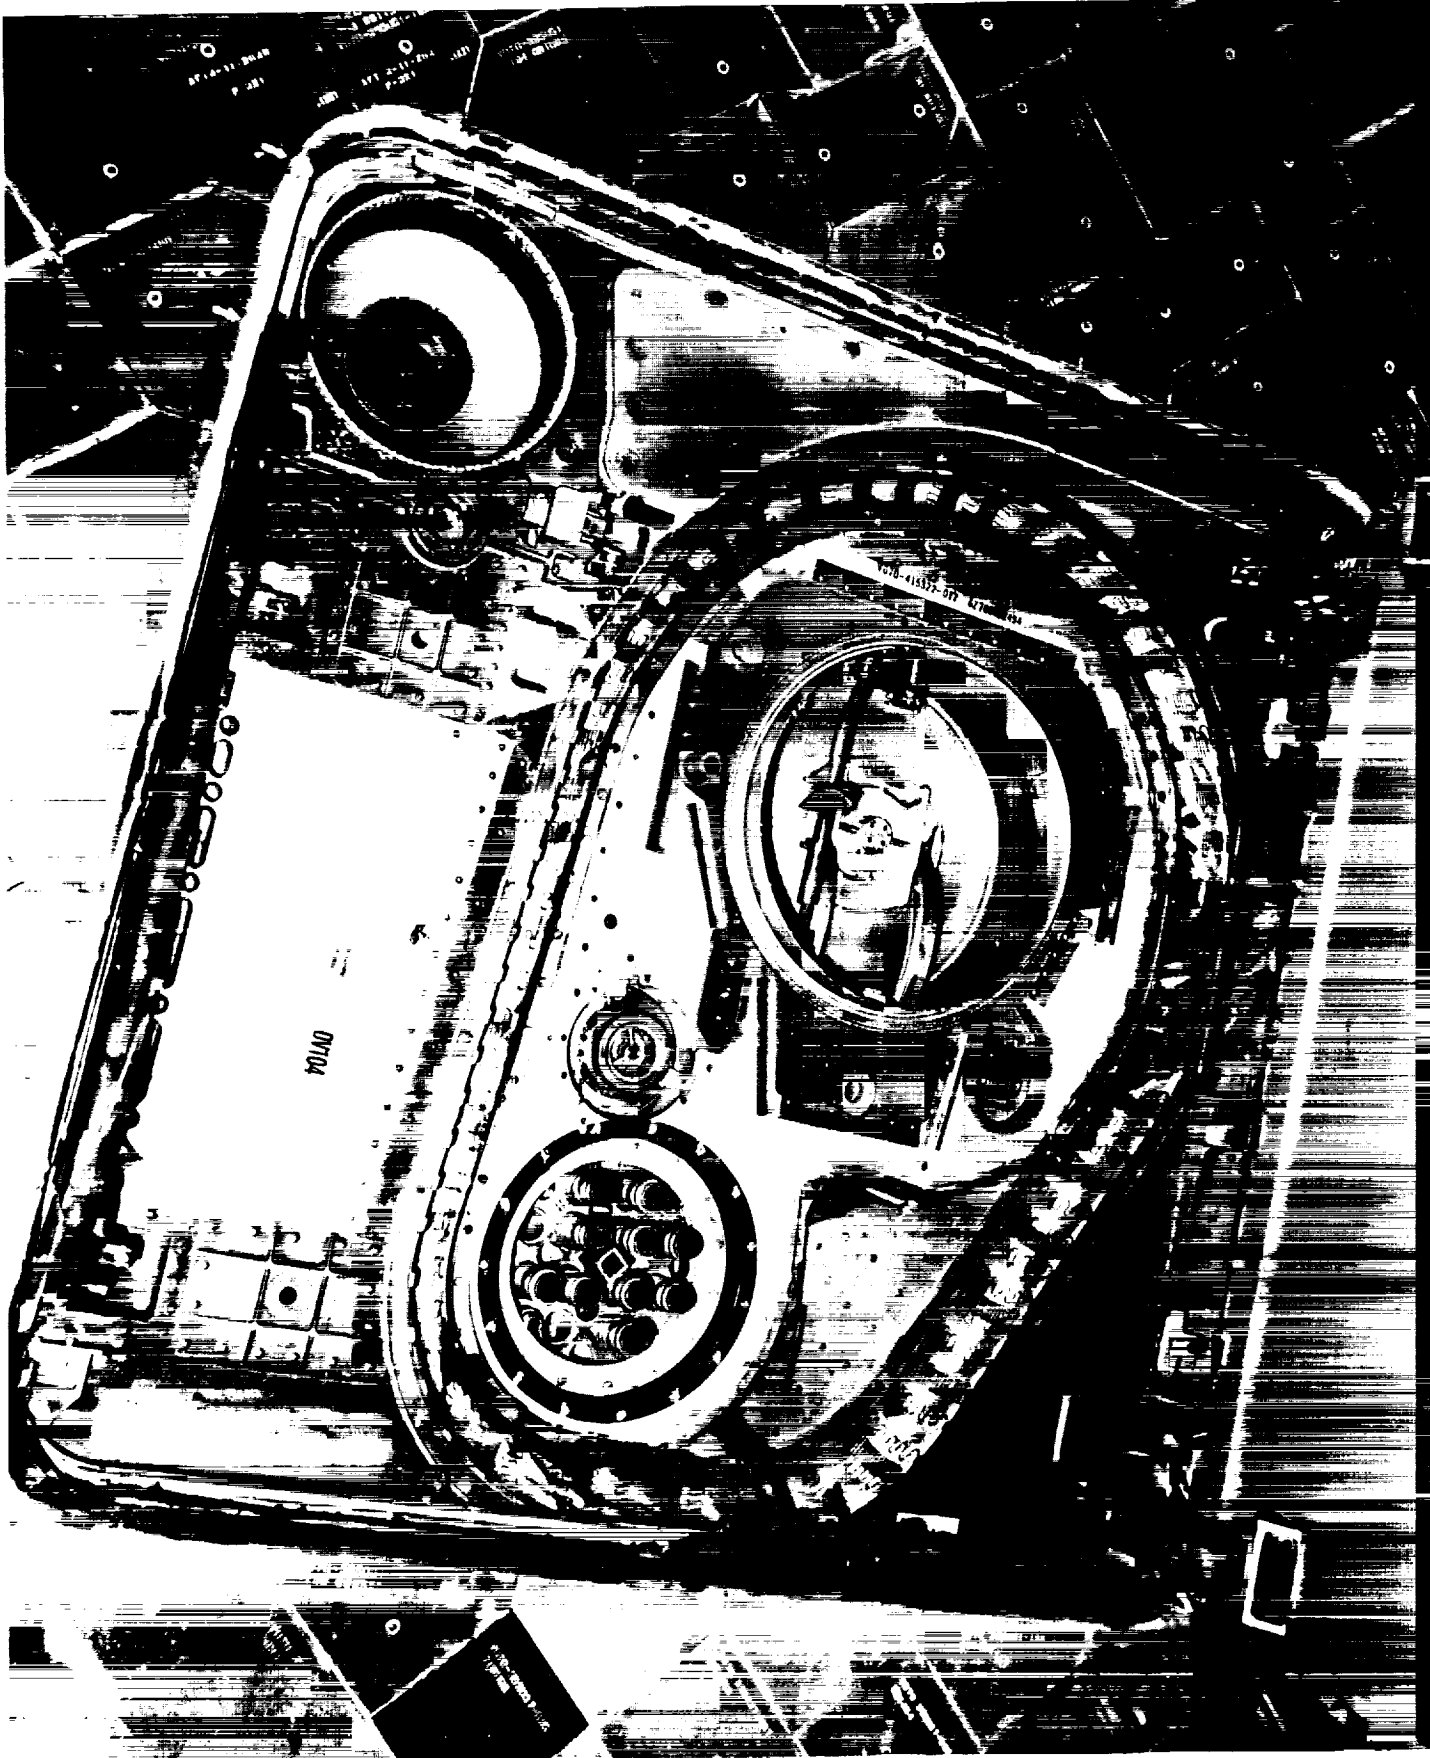
Overall view of the L02 ET/ORB umbilical. All separation ordnance devices appeared to have functioned properly. No flight hardware was found on the runway below the umbilical when the ET door was opened.

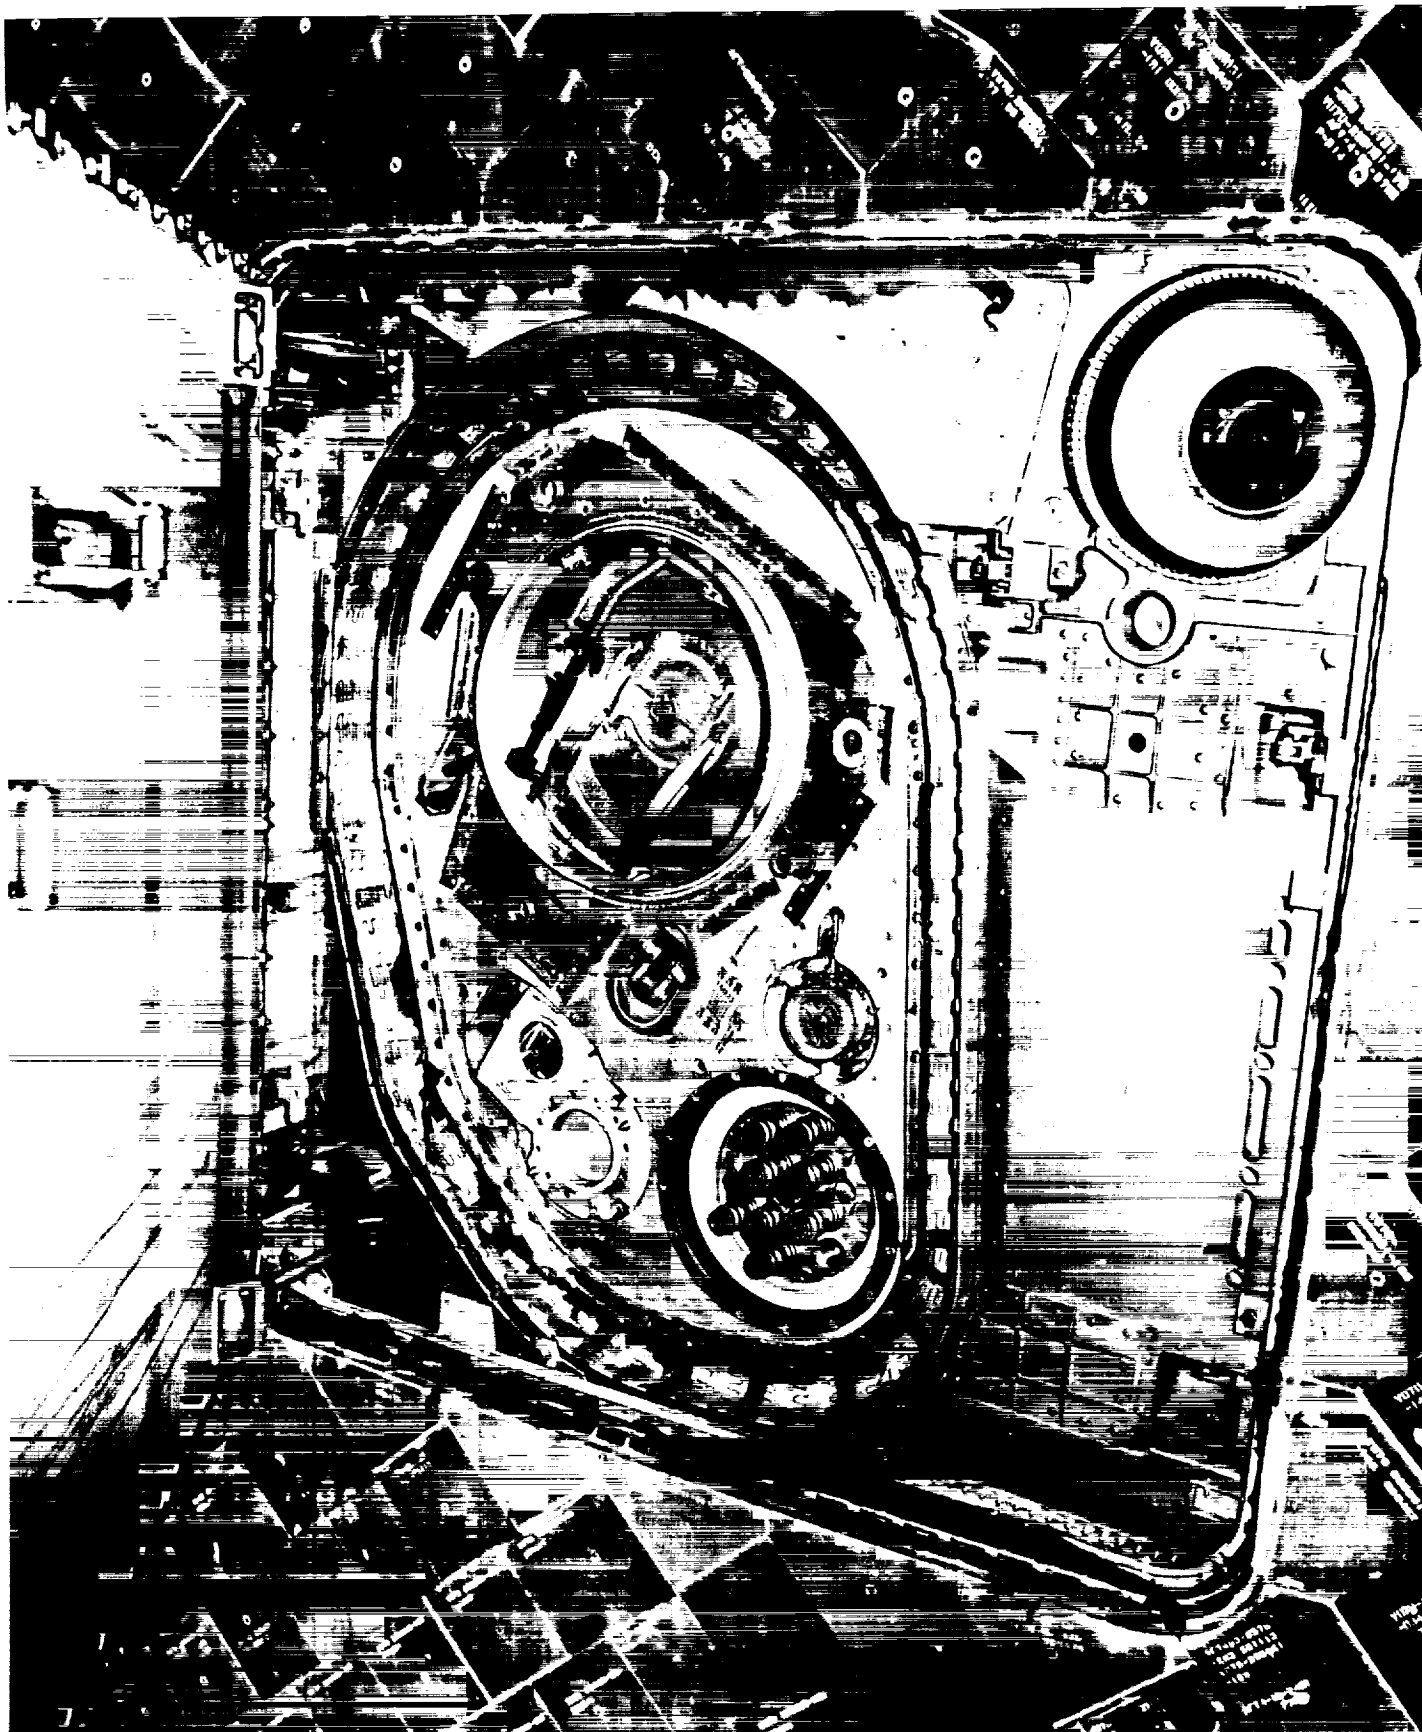
Overall view of the LH2 ET/ORB umbilical. All separation ordnance devices appeared to have functioned properly. No flight hardware was found on the runway below the umbilical when the ET door was opened.
